CORROSION OF MATERIALS IN HYDROSPACE

PART III - TITANIUM AND TITANIUM ALLOYS

Technical Note N-921

Y-F015-01-05-002a

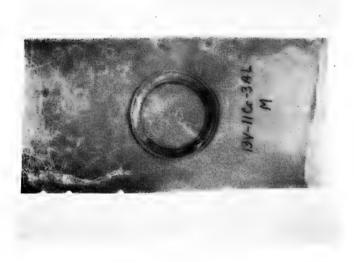
Alloys 75A, Ti-0.15Pd, 5A1-2.5Sn, 7A1-2Cb-1Ta, 6A1-4V and 13V-11Cr-3A1 were exposed with an unrelieved 3-inch diameter circular weld bead in the center of 6" x 12" specimens as shown in Figure 3. Only the 13V-11Cr-3A1 alloy failed by stress corrosion cracking because of the residual welding stresses. Cracking occurred during surface exposure of 181 days, during 403 days of exposure at a depth of 6,780 feet, during 751 days of exposure at a depth of 5,640 feet, and during 402 days of exposure at a depth of 2,370 feet. The cracks in all cases were radial across the weld beads, a typical crack is shown in Figure 7. The crack in this case changed direction by 90 degrees (left side of Figure) just outside the weld bead because of the redistribution of the residual stresses.

Figure 3. Circular weld (3" diameter) in 6" x 12" specimen, unrelieved.

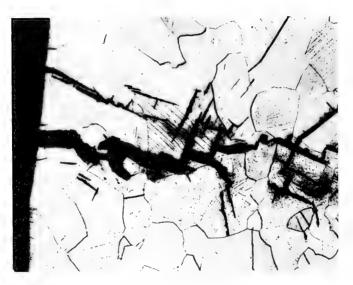
Metallographic examinations of unetched and etched sections in a plane parallel to the surface of the specimen showed that a secondary crack which started at the edge of the specimen in the parent metal away from and parallel to the main fracture was irregular and branching in nature as well as transgranular as shown in Figure 6. This is typical of the main fracture.

Figure 6. Secondary crack in parent metal away from and parallel to main fracture. Crack is branching in nature and transgranular. Etched in lactic, hydrofluoric and nitric acid mixture. X100.

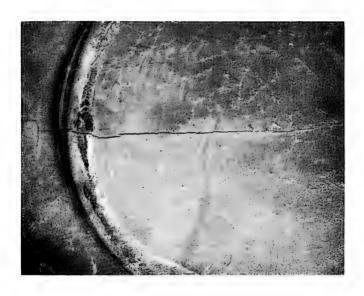
Figure 7. Radial stress corrosion crack across weld bead of 13V-11Cr-3A1.

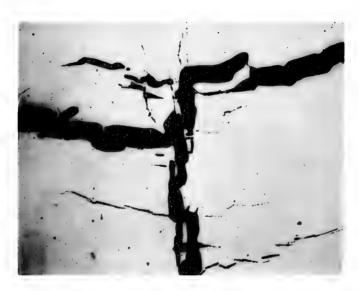
Metallographic examination of a polished section of the crack taken in the plane of the sheet where it changed direction showed that the path of the crack was irregular and branching in nature as shown in Figure 8. After etching and reexamination it was found that the crack was predominantly transgranular as shown in Figure 9.

Figure 8. Irregular, branching stress corrosion crack in 13V-11Cr-3A1. Unetched. X100.
